Division of Oil, Gas and Mining

Inspection Report Minerals Regulatory Program February 20, 2013

Mine Name: Kennecott Tailings	Permit Number: M/035/0015
Operator Name: Kennecott Utah Copper	Inspection Date: May 09, 2012
Inspector(s): L Heppler, P Brinton	Time: 2:00 PM
Other Participants: Zeb Kenyon - Kennecott	Mine Status: Active

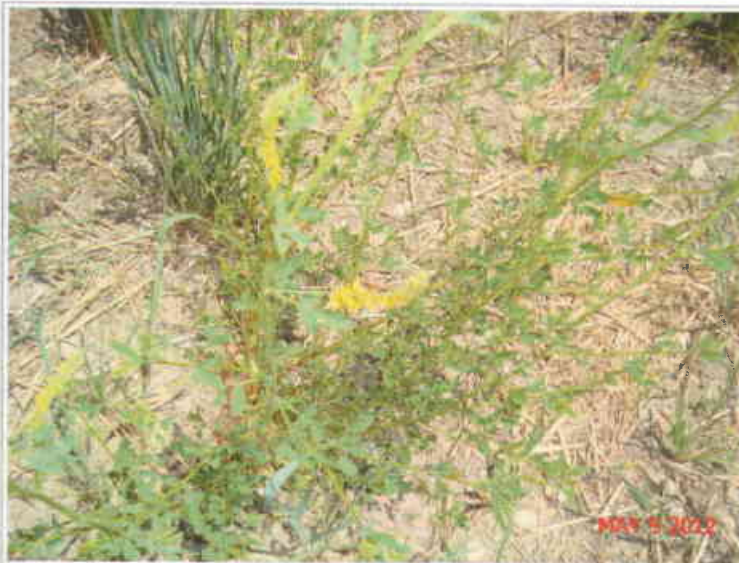
Close up of yellow sweet clover

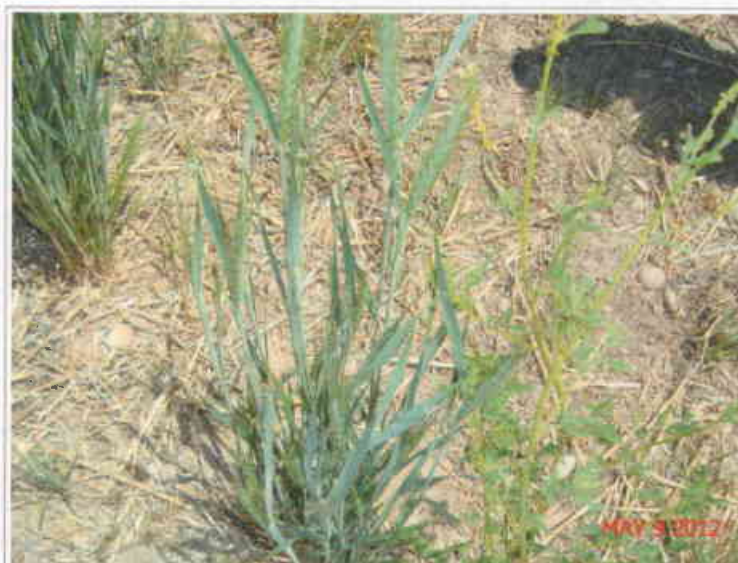
Close up of wheat grass that dominates the site

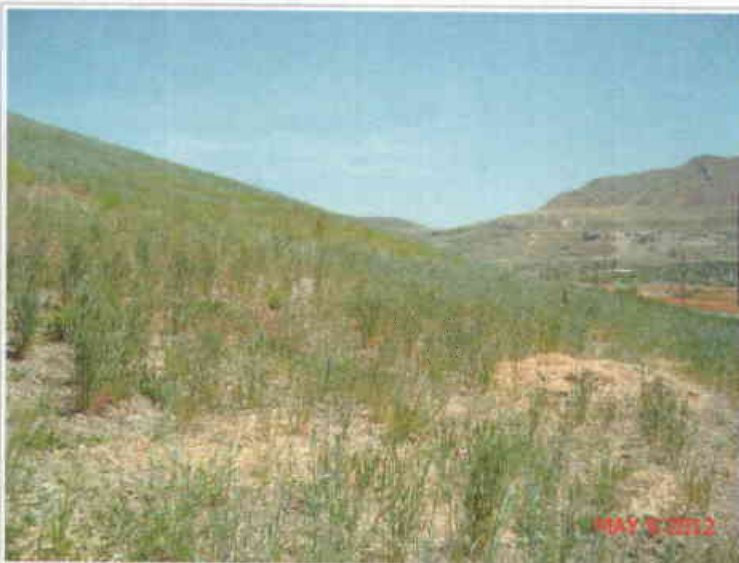
New Vegetation

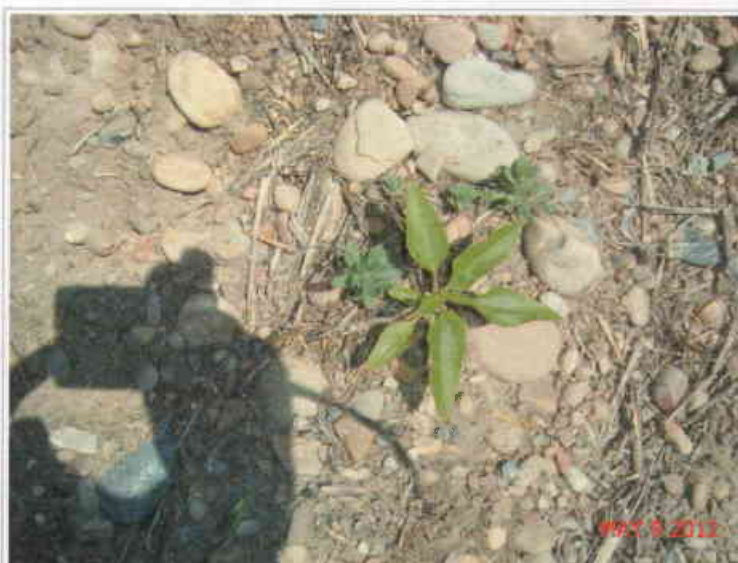
Close up of Sunflower seedling
